EASA	EMERGENCY AIRWORTHINESS DIRECTIVE

<p>AD No.: 2006 – 0310-E</p> <p>Date: 11 October 2006</p>	
No person may operate an aircraft to which an Airworthiness Directive applies, except in accordance with the requirements of that Airworthiness Directive unless otherwise agreed with the Authority of the State of Registry.		
Type Approval Holder's Name :		Type/Model designation(s) :
STEMME GmbH & Co. KG		STEMME S 10
TCDS Number: EASA.A.054		
Foreign AD : N/A		
Supersedure : N/A		
ATA 73	Engine and Fuel Control - Fuel Connector - Hose Connector 10AB-75 - Inspection / Identification / Replacement	
Manufacturer(s):	STEMME AG, STEMME GmbH & Co. KG	
Applicability:	<p>S10: 10-03 up to 10-56</p> <p>S10-V: 14-001 up to 14-030 and all converted variants 14-003M up to 14-056M</p> <p>S10-VT: 11-001 up to 11-100</p>	
Reason:	<p>A leaking brass fuel connection (part no. 10AB-75) was found during maintenance check.</p> <p>This brass fuel connection was for the first time introduced with the SB A31-10-061 „Additional Measures fire protection S10-VT“ and with the SB A31-10-063 „Additional Measures fire protection for S10 and S10-V (US mandatory). These brass connections were used later in serial prod

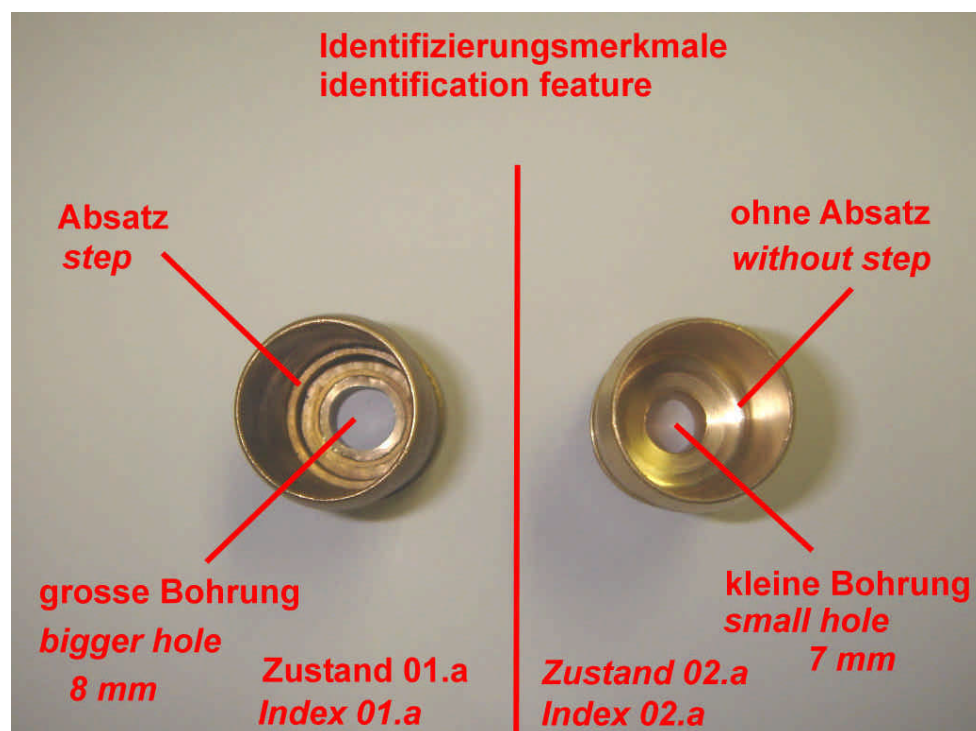
Während Wartungsarbeiten wurde an einem Flugzeug eine Undichtigkeit der Schlauchkupplung in Messingbauart (10AB-75) gefunden.

Der undichte Schlauchverbinder entsprach dem Konstruktionsänderungszustand 01.a, dieser war gültig von Februar 2002 bis April 2002. Im April 2002 wurde eine modifizierte Variante dieses Schlauchstutzens eingeführt, da die alte Version sich als anfällig auf unsachgemäße Montage- und Wartungsarbeiten herausstellte. Die modifizierten Schlauchverbinder haben den Konstruktionsänderungszustand 02.a.

- Trennen der Schnelltrennkupplungen zwischen Flügel und Rumpf
- bei befüllten Kraftstofftanks die jeweilige Flügelseite durch eine zweite Person nach unten drücken, so das kein Kraftstoff mehr im gelben Tygon-Schlauch zu sehen ist.
- Lösen der Klemmschelle des Schlauchverbinders
- Identifizierung des Konstruktionsänderungszustandes gemäß der bildlichen Darstellung

- bei Identifizierung des **Konstruktionsänderungszustand 01.a** erfolgt **Maßnahme 3**
- bei Feststellung des Konstruktionsänderungszustandes 02.a erfolgt die Wiedermontage des vorhandenen Schlauchverbinders mittels der ebenfalls vorhandenen Klemme
- Kontrolle auf Festsitz und Dichtigkeit
- Maßnahme 2 zur Identifikation des Bauzustands auch auf der anderen Flügelseite durchführen

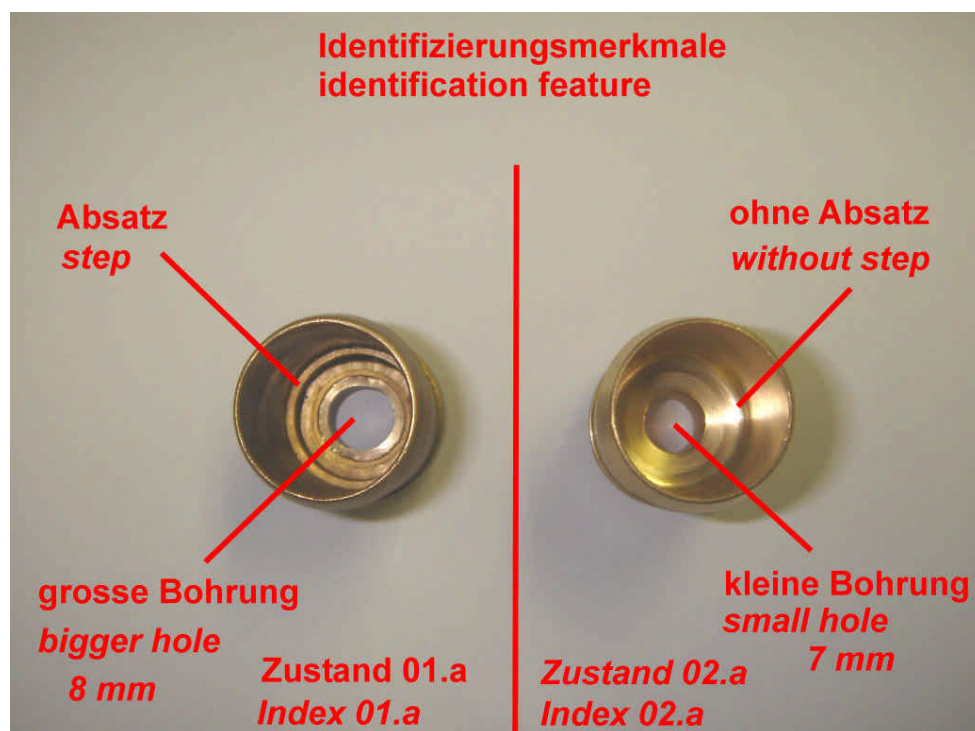
A leaking brass fuel connection (part no. 10AB-75) was found during maintenance work.

The leaking brass connector was according to the design modification index 01.a. It was valid for the period February 2002 until April 2002. A modified version of the hose connector was introduced in April 2002, after the old version turned out to be susceptible to improper assembly and maintenance work. The modified version has the design modification index 02.a.

- disconnect the quick-type fuel connectors between the wing and the fuselage
- If the fuel tanks are not empty, a second person should push down the wing to be inspected by hand. No fuel must be visible inside of the yellow "Tygon"-hose.
- unscrew the clamp for the hose connector 10AB-75
- visual identification of the design modification index of the hose connector according to the picture:

- if the **design modification index 01.a** will be identified: next step must be **action 3**.
- the existing fuel connector may be reassembled with the existing clamp if the design of the hose connector 10AB-75 confirms with modification index 02.a
- Inspection for tight mounting and leak tightness
- repeat action 2 (identification of installed version) for the other side of the wing
